State of Nevada  
Department of Corrections  
Florence McClure Women's Correctional Center  
Facility Condition Analysis

# FLORENCE McCLURE WOMEN'S CORRECTIONAL CENTER

4370 Smiley Road  
North Las Vegas, Nevada 89115

**Site Number: 9893**  
**STATE OF NEVADA PUBLIC WORKS DIVISION**  
**FACILITY CONDITION ANALYSIS**

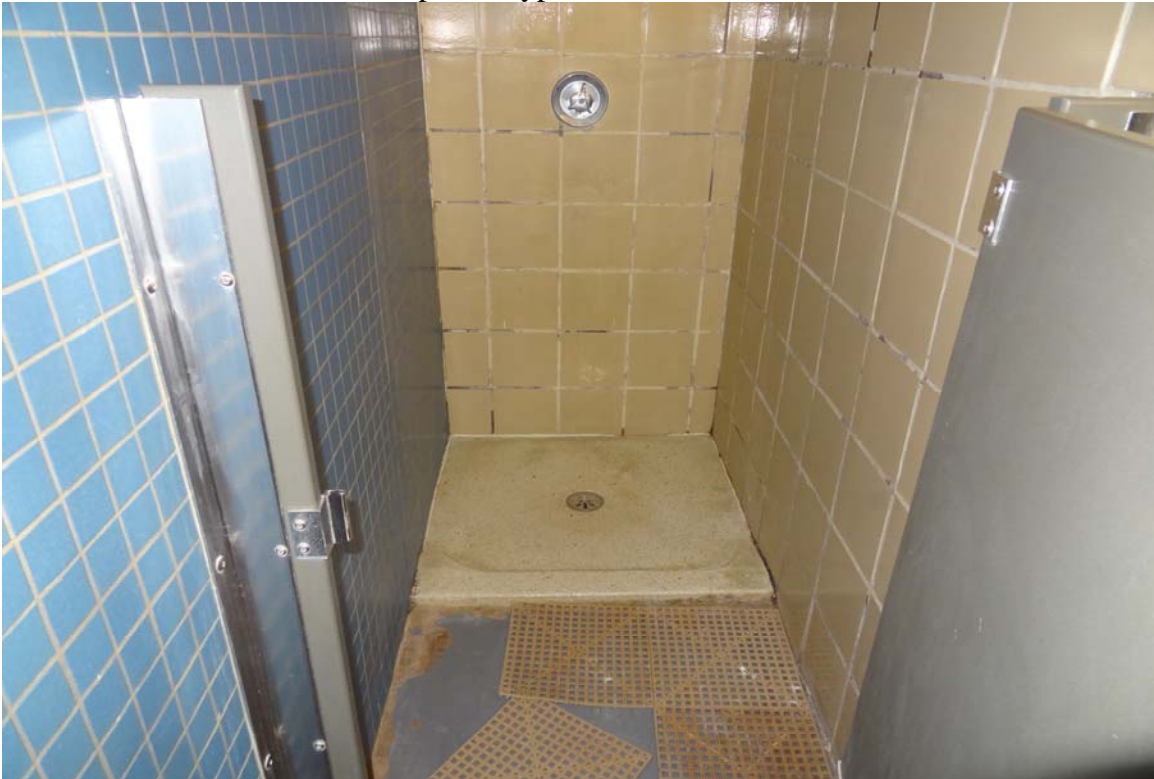
The shower ceilings, walls, floors and fixtures in Housing Units A & B are in poor condition and should be scheduled for replacement. The gypsum board ceiling has been removed and the ceramic tile walls and painted concrete flooring are damaged and failing. The exposed pipes at the ceiling are rusting and should not be exposed to the wet environment and is also a safety concern for inmates. This project would provide for removing the walls, ceilings, flooring and fixtures and replacing them with a uniform ceramic tile finish or stainless steel units. Removal and disposal of the existing materials is included in the estimate.

Administration / Housing Units - Building #2457  
Description: Typical showers in need of repairs.

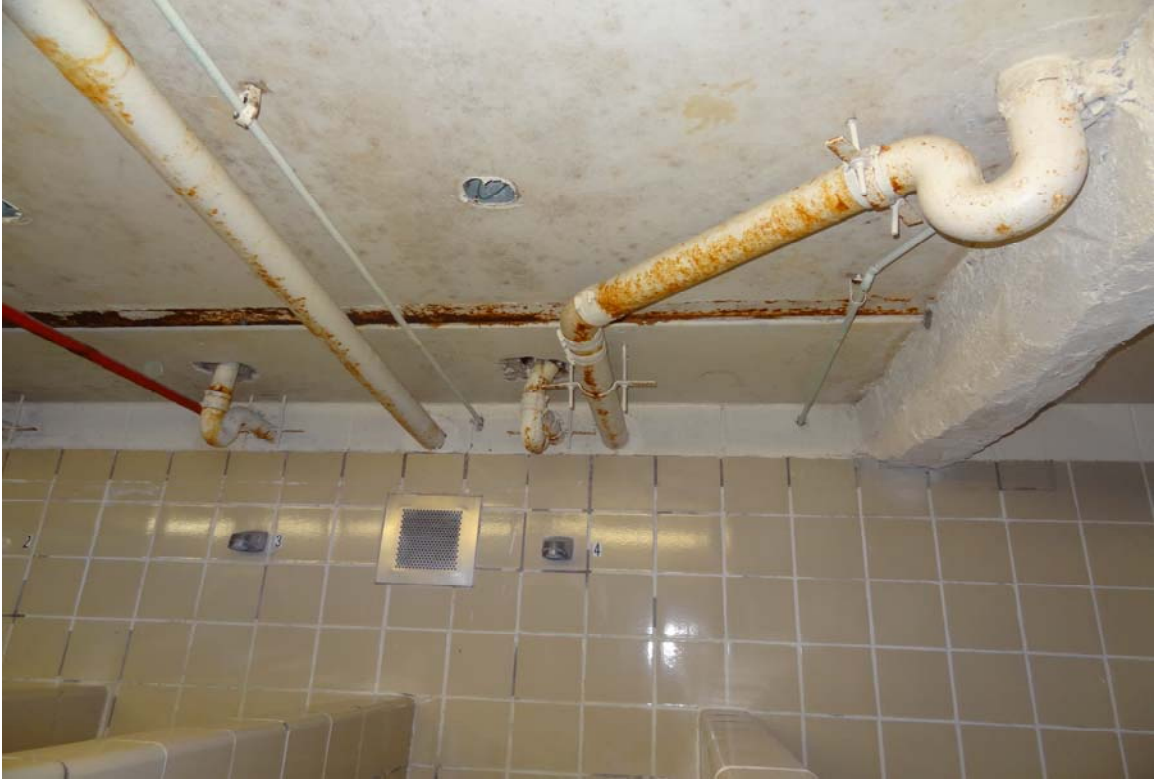
Administration / Housing Units - Building #2457

Description: Ceiling at showers in need of repair.

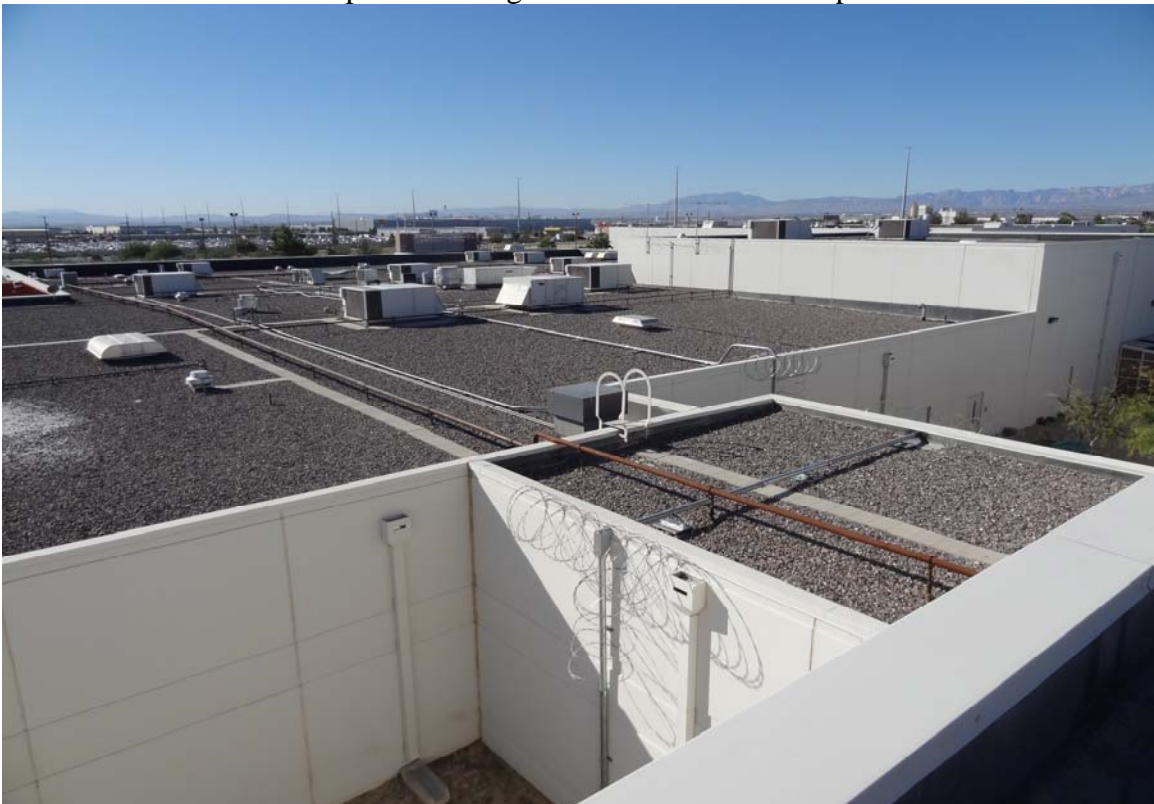
Administration / Housing Units - Building #2457

The roof on the 1997 portion of the building was in fair to poor condition at the time of the survey. The built-up ballasted roof system is 15 years old and numerous leaks have occurred recently. It is recommended that this older ballasted roof be replaced with a single-ply membrane system in the next 2-3 years. The new membrane will have a 20 year warranty with a preventative maintenance agreement to ensure that any future leaks will be repaired by the manufacturer.

Description: View of ballast roof in need of replacement.

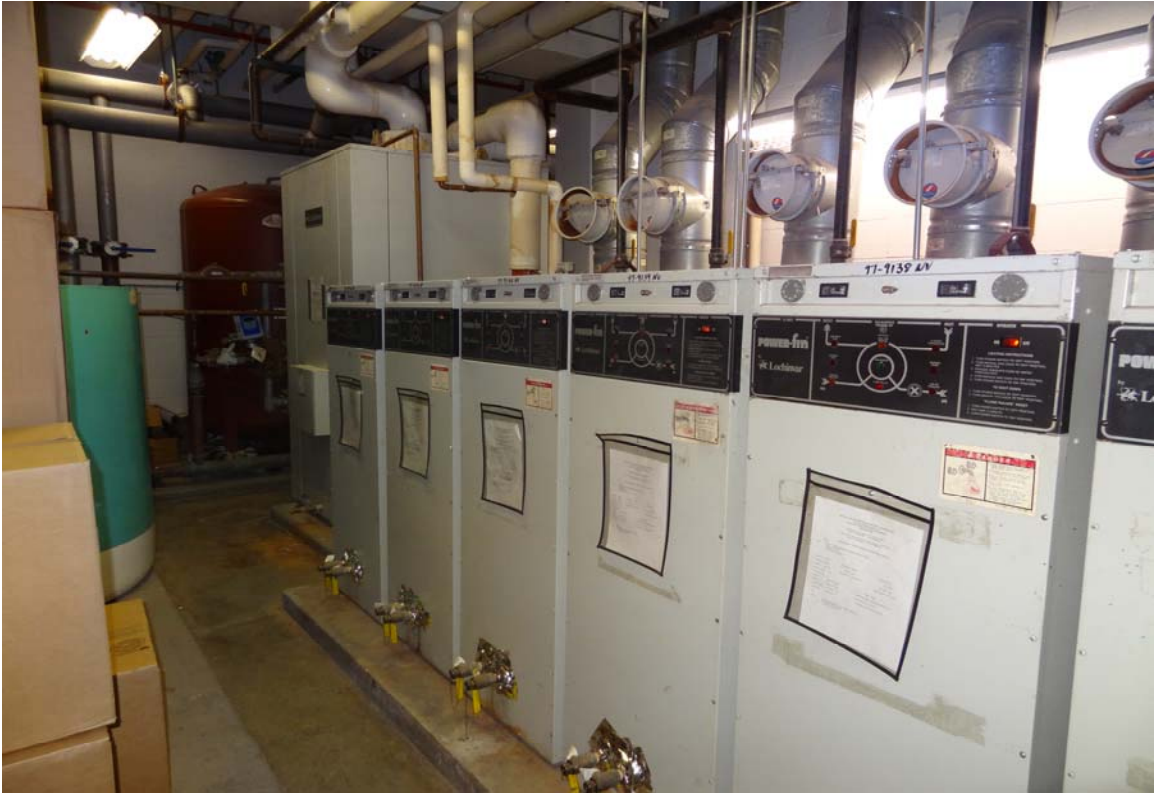
The existing HVAC system in the original 1997 portion of the building consists of (6) 1,281 MBH output Lochinvar hot water boilers and approximately 38 roof top evaporative coolers and packaged units. They are not energy efficient and have reached the end of their expected and useful life. This equipment is original to the building and should be scheduled for replacement. This project would provide for replacing the boilers, the boiler controls, mixing valves, evaporative coolers and packaged units with new equipment and includes removal and disposal of the existing HVAC units and all required connections to utilities.

Administration / Housing Units - Building #2457  
Description: Boilers in Mechanical Room.
